Manhole Inspection Summary

Manhole # S25I__010MH

Insp Date: **3/20/08 9:57 AM**

Location Address: **117 S.CAREY ST.**

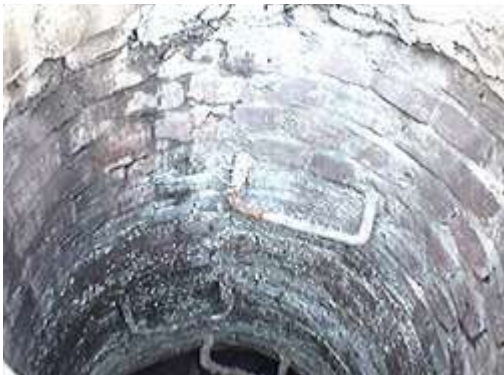
Defect 6

MISSING MORTAR AT CHIMNEY WITH EVIDENCE OF INFILTRATION AND DETERIORATED CORBEL

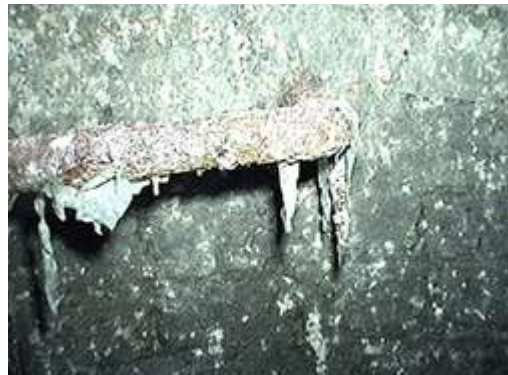
Defect 5

CORRODED STEP WITH EVIDENCE OF SURGE

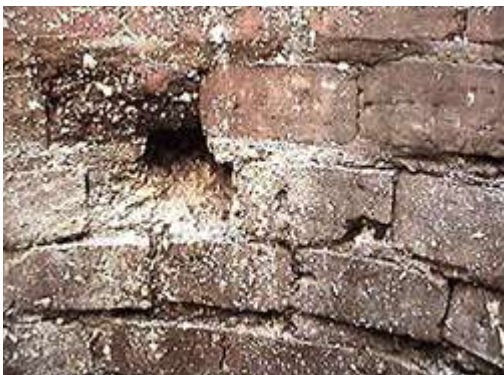
Defect 2

DETERIORATED CORBEL WITH MISSING BRICKS

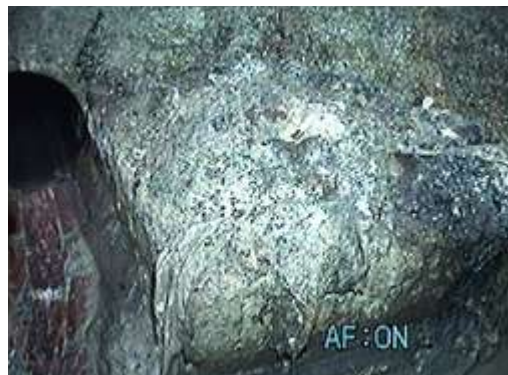
Defect 1

EVIDENCE OF SURGE ON BENCH

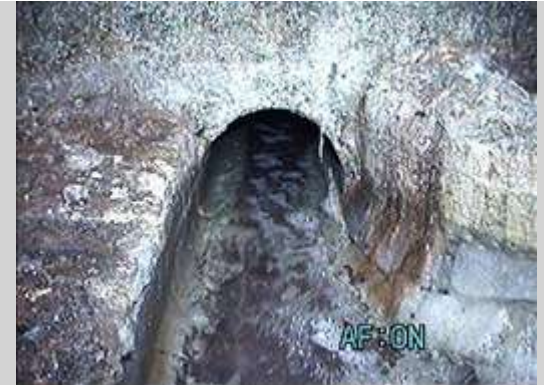
12 O'Clock Outflow

Pipe Height: **8.4** (in.) Rod and Bar (Angled)
Pipe Material: **Clay** ☐ Pipe Lined
Invert Depth: **11.26** (ft.) Flow Characteristics: **Slow**
Deposits: ☒ None ☐ Mud ☐ Sludge ☐ Debris ☐ Grease
Silt Depth: **0** (in.) Deposits Extent:
Infiltration: **None** Pipe Seal Cond: **Unknown**

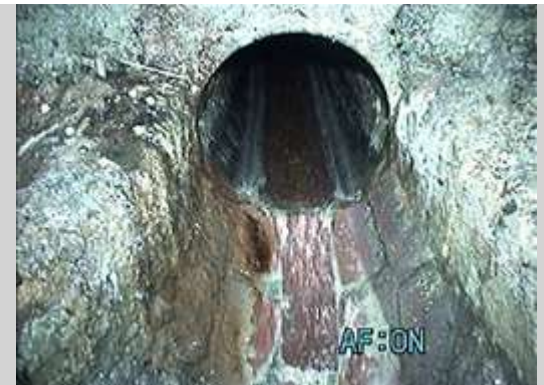
3 O'Clock Inflow

Pipe Height: **8.4** (in.) Rod and Bar (Angled)
Pipe Material: **Clay** ☐ Pipe Lined
Invert Depth: **10.79** (ft.) Flow Characteristics: **Slow**
Deposits: ☒ None ☐ Mud ☐ Sludge ☐ Debris ☐ Grease
Silt Depth: **0** (in.) Deposits Extent:
Infiltration: **None** Pipe Seal Cond: **Unknown**

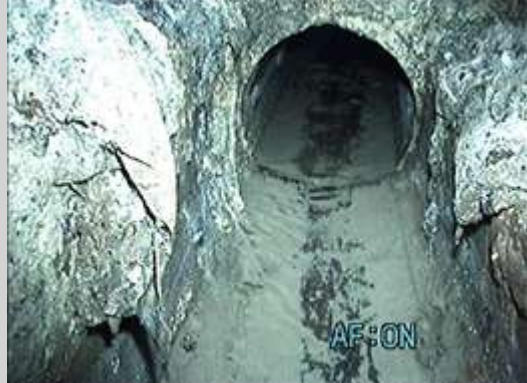
6 O'Clock Inflow

Invert Depth: **11.15** (ft.) Flow Characteristics: **None**

Silt Depth: **0.25** (in.) Deposits Extent:
